# 248-nm UV Damage Mechanism in MPP CCD's

DALSA Inc.

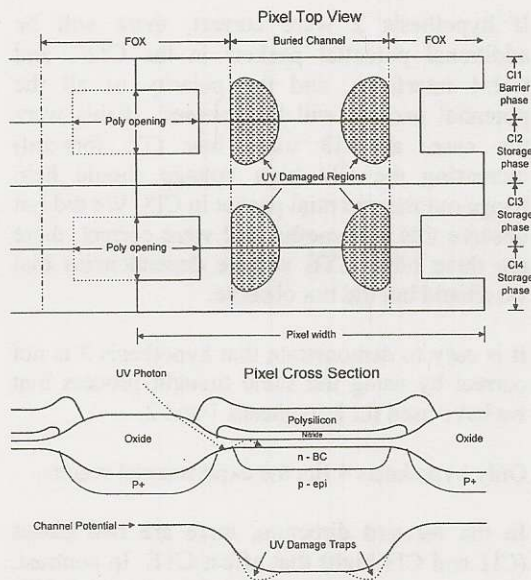
**Figure 1.**  
**UV Damage Location in the Photosite.**  
The figure is drawn for illustrative purposes only. Dimensions are not drawn to scale.

The damage is located in the area adjacent to the poly openings as illustrated in Figure 1. We have approximated the reach of internally reflected UV photons.

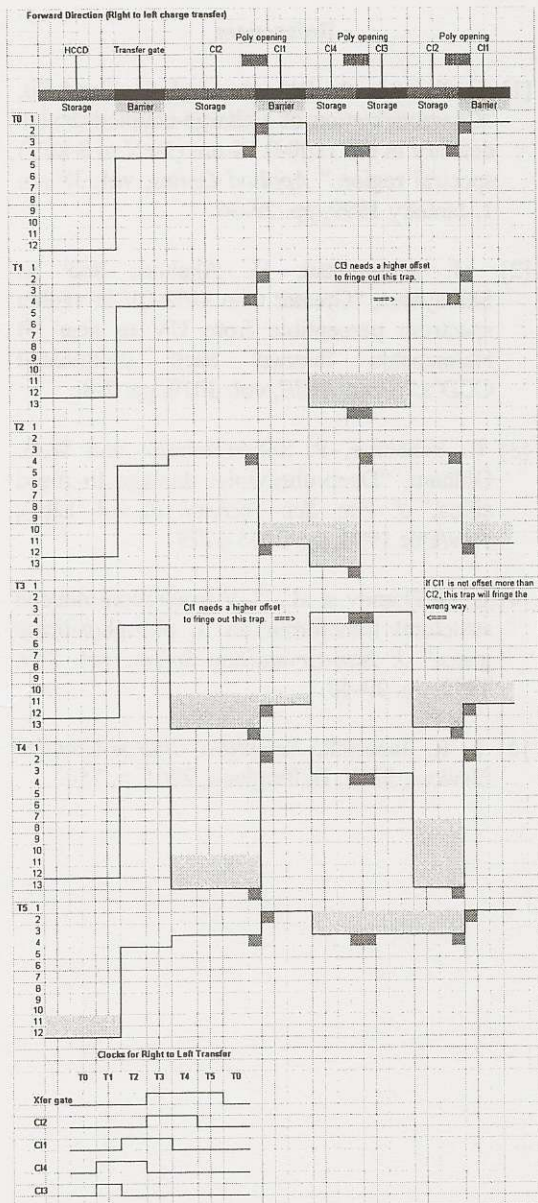
Figures 2 and 3 illustrate the potential well diagrams in the forward and reverse modes respectively. The poly openings straddle CI1 and CI2, as well as CI3 and CI4, as shown in Figure 1. We marked the locations of the poly openings using dark boxes above the poly gates. The dark boxes in the potential wells indicate the locations of the potential traps. Although we have drawn the trap location and polarity to be consistent with hypothesis no. 4, it is fairly easy to mentally modify the picture to fit the other three hypotheses.

**Figure 2.**  
**MPP CCD potential well diagram illustrating UV-induced potential packet locations. Forward direction charge transfer is shown. The dark boxes in the potential well indicate potential trap locations.**

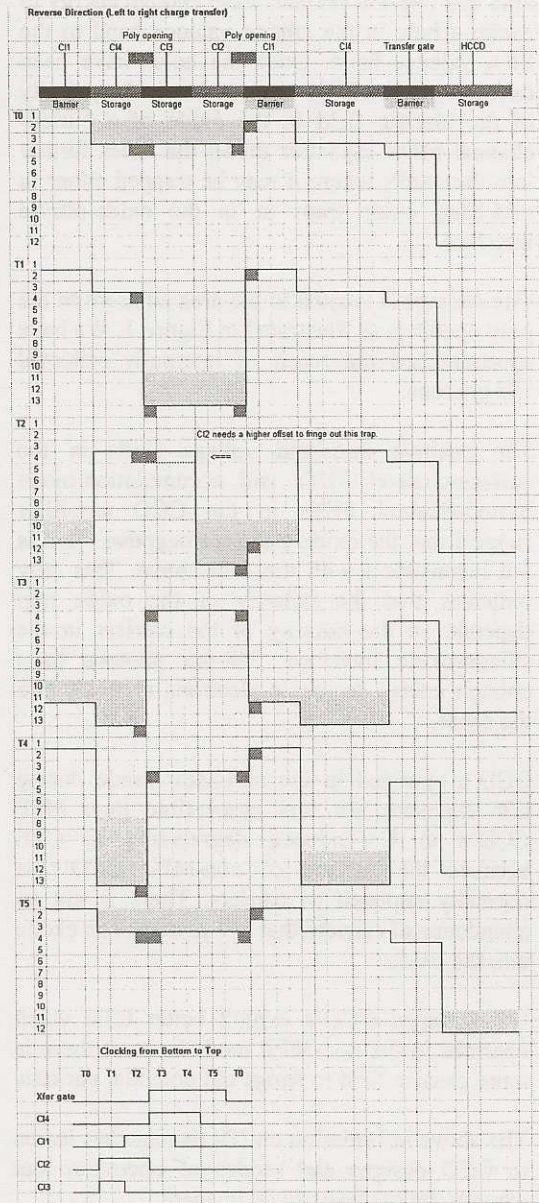
**Figure 3**  
**MPP CCD potential well diagram illustrating UV-induced potential packet locations. Reverse direction charge transfer is shown. The dark boxes in the potential well indicate potential trap locations.**
