R37: Technology to Eliminate Yield-Limiting Elements in CCD Imagers

Philips Semiconductors
Image Sensors

Abstract

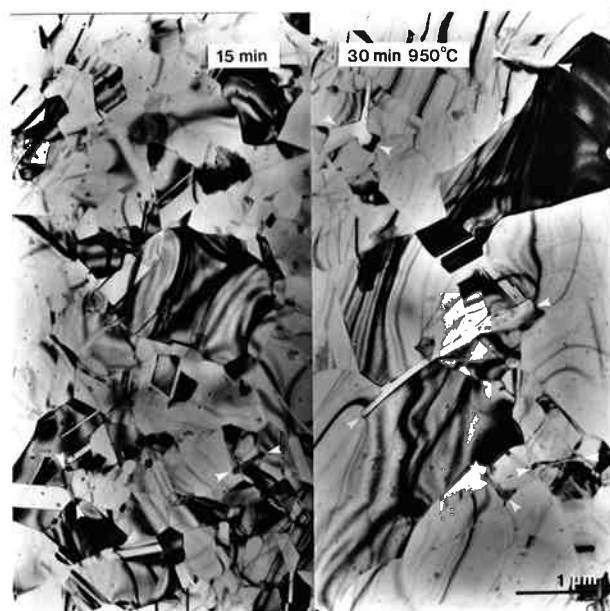
Fig. 4. Plan-view TEM images of POCl_3 -doped poly-Si at 950°C for 15 and 30 minutes. SiP precipitates are indicated by white arrows.

For this purpose samples with meander shaped test structures in 0.4 μm poly-Si were made. The poly-Si films were doped in a POCl_3 furnace at 950°C for 15 minutes (standard conditions) and 30 minutes. Fig. 4 shows plan-view TEM images of both poly-Si films, clearly showing much larger grains for the 30 minutes sample. Also very clear is the presence of a second phase along the grain boundaries (indicated by white arrows) with a typical size of several μm 's. After careful inspection of the 15 minutes sample these precipitates were found as well. The density of precipitates is estimated to be about 1×10^7 per cm^2 and their typical size is 80 by 500 nm. As visible in fig. 4 the typical size of the precipitates is much larger for the 30 minutes sample. Hence further identification of these precipitates was performed with the 30 minutes sample.

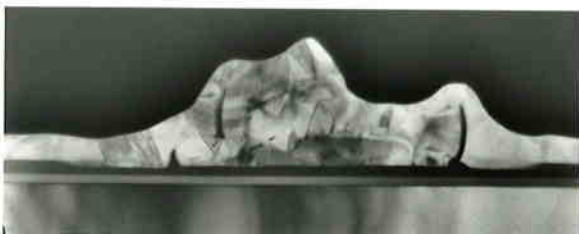
Fig. 9 TEM cross-section of situation in fig. 8d

Now a very uncritical but very important mask-less wet oxide etching can be applied (fig. 8c). It is the underetching and the perfect filling of the cavities underneath the nitride with poly-Si 3 that assures a very tight and reliable connection between the three poly-Si structures (fig. 8d). This connection looks like a click-button and can best be seen in a cross-section in the other direction. Fig. 9 shows a TEM cross-section of fig. 8d.
