Image Artifacts Caused by Pixel Bias Cells in CMOS Imagers targeted for mobile applications

ST Microelectronics Imaging Division
Edinburgh, Scotland, UK

Abstract—The quality of an image produced by a CMOS image sensor is strongly linked to the quality of the pixel bias cells. However the voltage or current bias circuits and their effect on an image is rarely written about in the literature. This paper describes a number of artifacts seen if the bias cells are not properly designed.

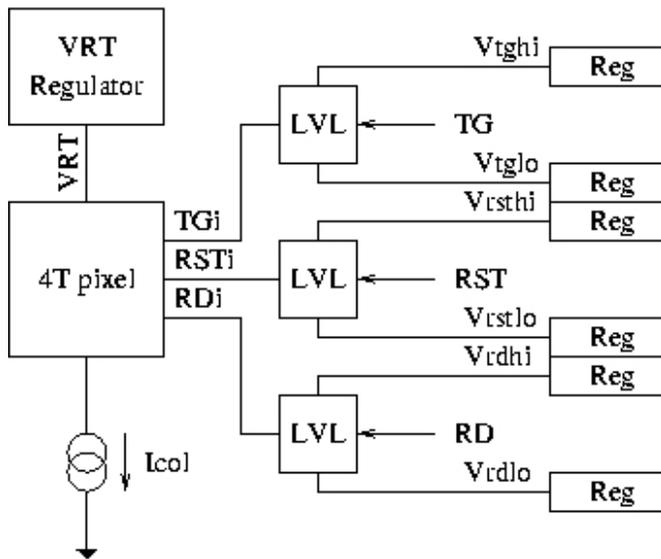
State of the art CMOS image sensors are built around the pinned photo-diode pixel [1]. To properly bias the pixel and enable it to work properly, eight bias cells are typically required. These are Vtgi, Vtghi, Vrstlo, Vrsthi, Vrdlo, Vrdhi, Vrt and Icol and are shown in Fig. 1.

Figure 1. The pixel and its bias cells

Icol and VRT are used to bias the pixel's source follower. VRT is also used as the floating diffusion node reset voltage. Vtghi and Vtgi are used to bias the pixel's transmission gate. Vrsthi and Vrstlo are used to control the reset transistor, whereas Vrdhi and Vrdlo are used to control the pixel's read transistor. All these biases should be designed to operate at low current, and not introduce image artifacts.

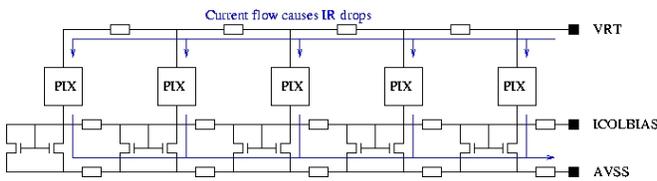
The main culprits for the IR based X droop is the routing for the VRT regulator and the routing for the column current source, as shown in Fig. 4. The drop in VRT from left to right causes an offset. The drop in I_{col} , causes a shift in the gain of the pixel source follower, which in turn leads to a droop.

Figure 4. IR based X-droop

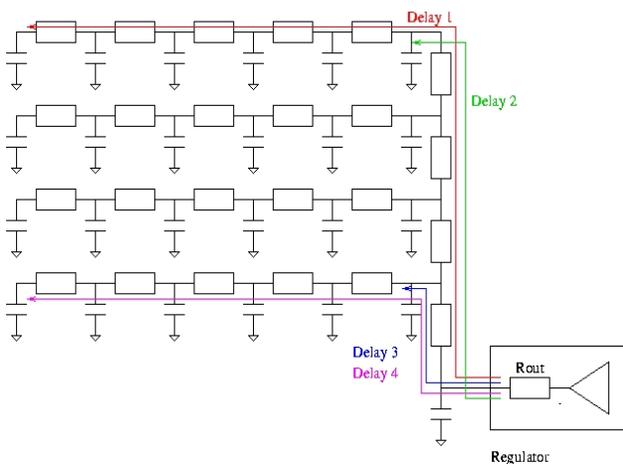
The time constant based X-Y droop is mainly caused by the delay of the TG, RD and RST tracks. However one must include into this delay the effects to the power tracks of v_{tghi} , v_{tglo} , v_{rsthi} , v_{rstlo} , v_{rdhi} and v_{rdlo} and the output impedance of the cells providing these biases, as shown in Fig. 5. The delay for the propagation of the pixel control signals must be low enough to ensure that the time constant induced offset does not introduce an offset in the image. The usual two main contributors are V_{tglo} and V_{tghi} , as CDS is not applied to them. The authors also note the poor rejection of the pixel to these biases.

Figure 5. Time constant X-Y droop

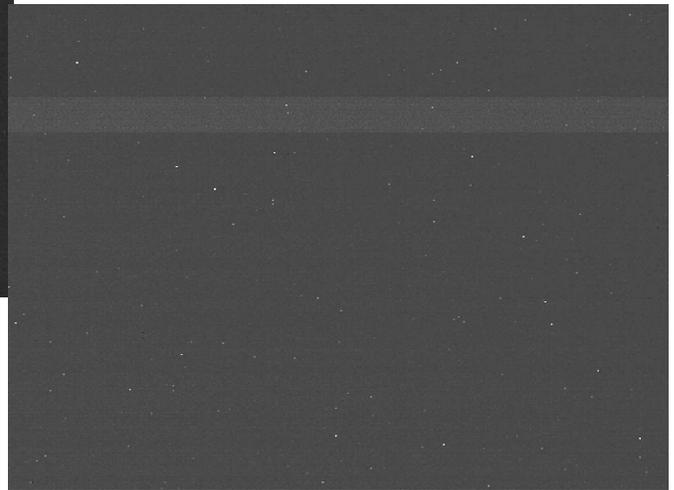
FIBAR (Fixed Integration bar) is an image offset, which is dependant on the integration time used. The FIBAR issue, shown in Fig. 9 appeared with the usage of frame extension. In a low light environment, frame rate is reduced in order to increase integration time. There are two methods to do this:

Figure 9. FIBAR in an image

either reduce the system clock speed (clock derating), or increase the frame length (frame extension). Frame extension is the preferred option as it does not affect the quality of the CDS operation. The FIBAR, shown in Figure 9 is caused by the fact that the kick on the supplies is not equal from line to line as shown in Fig. 10.

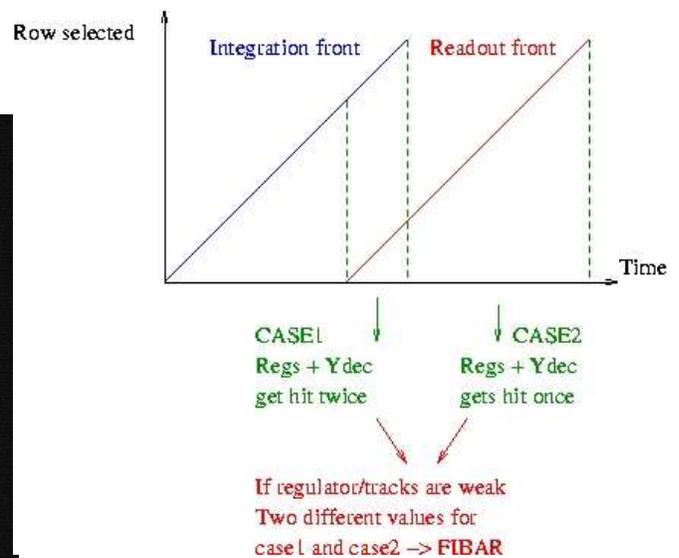
Figure 10. Explaining the FIBAR

The FIBAR phenomenon can be reduced by careful timing, but one must be careful not to increase the current consumption too much.

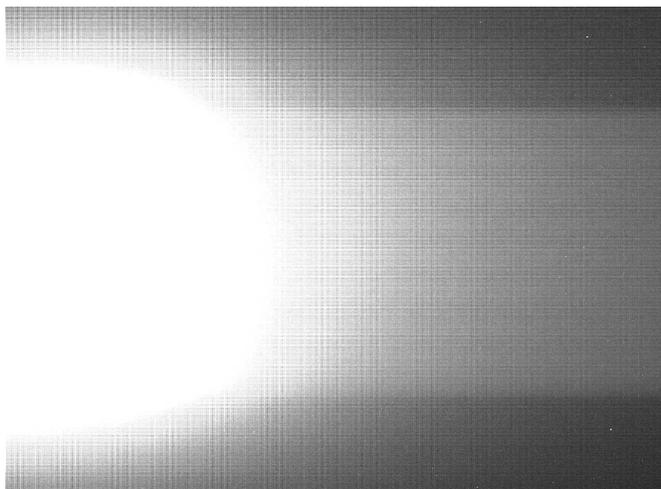
Smearing can be seen when a picture has a bright line on it, as shown in Fig. 11. In most cases it is caused by the quality of the ground plane of the sample and hold circuit. However

Figure 11. Smearing

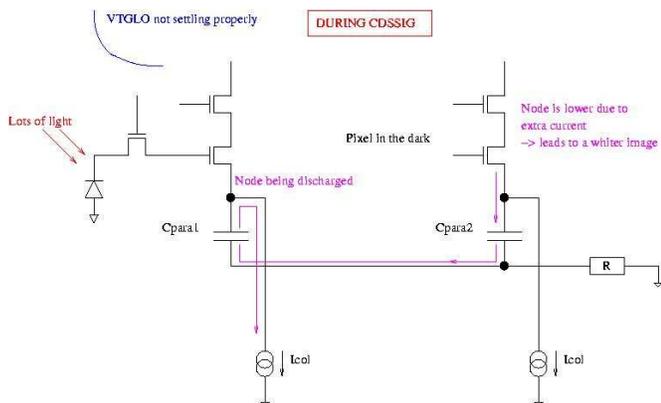
on more recent chips with high resolution it seems it is caused by the settling of the Vt_{glo} regulator. The possible mechanism is shown in Fig. 12.

Figure 12. Vt_{glo} contribution to smearing

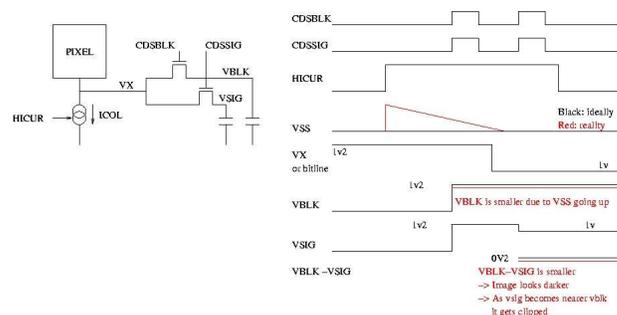
Black chopping, shown in Fig. 13 occurs when the ground plane changes between the two cds samples, described in Fig. 14. The shift in the ground is caused by the power saving features on the regulators used to reduce overall current consumption. One must be careful about the settling of the ground plane with respect with the current kicks when powering on and off the pixel biases.

Figure 14. Explaining black chopping
